REHABILITATION OF WATER-DAMAGED RUNWAY COMPOSITE PAVEMENTS

By:
Seiya Hama
Narita International Airport Corporation
NAA Building, Narita International Airport, Narita 282-8601
JAPAN
Phone: +81 476 34 5677; Fax: +81 476 34 5985
s-hama@naa.jp

PRESENTED FOR THE
2014 FAA WORLDWIDE AIRPORT TECHNOLOGY TRANSFER CONFERENCE
Galloway, New Jersey, USA

August 2014

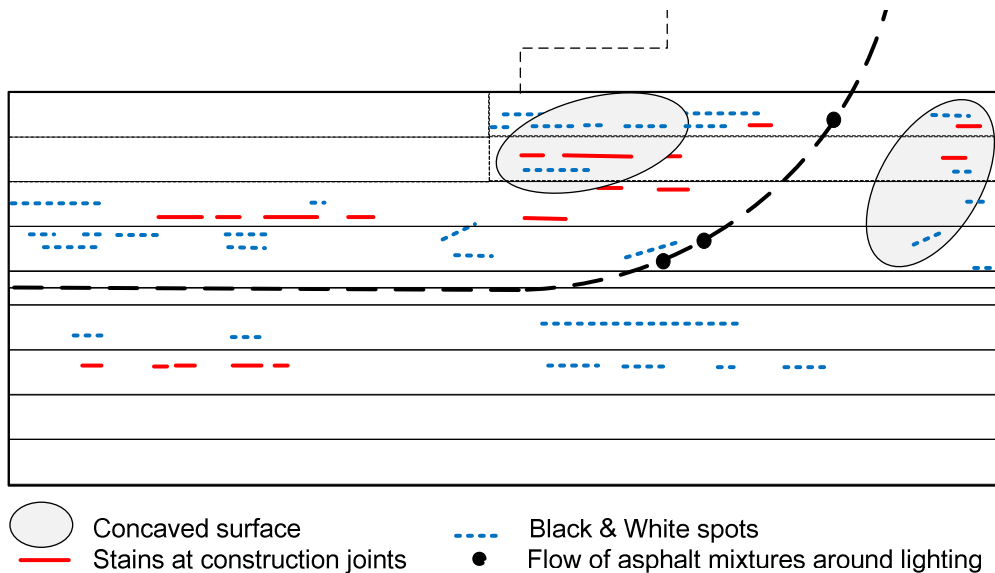
Figure 3. Signs of Distress Found on Composite Pavement Surface.

Several signs of distress were found on the composite pavement a few months after being opened to traffic as shown in Figure 3. The conditions of the distress were often surveyed ever since then and the results are briefly described below.

- Dull sound when subjected to hammer tapping tests
Found mostly in locations where aircraft landing gear passes.
- Black spots
Found in the central area of the runway.
- White spots
Found throughout the entire section.
- Stains at construction joints
Found at construction joints of the surface course.
- Flow of asphalt mixtures around lights
Found in the segment connecting the exit taxiway where an aircraft nose gear passes.

The dull sound heard at hammer tapping tests is thought to derive from the following two factors: fractures in the asphalt mixtures and separation of the upper and lower layers.

It is clear from the results of 3D-FEM that the separation between the asphalt mixture layers is caused when the bonding strength between two layers is too small and the strength of surface course asphalt mixtures is also too small.

Moreover, it was found that some water remained in the asphalt mixtures and the amounts in both dull sounding areas and areas where water seeps out on the pavement surface were higher than that in the sound areas. It is said that water remaining in asphalt mixtures evaporates with a rise in temperature and generally disappears. It is estimated from the results of the tests on the cores that a coefficient of permeability of asphalt mixtures decreases to 10^{-10} cm/s as the air voids is about 2% (Sasakawa and Okada [5]). This might cause the blistering in the asphalt mixture layers if the water remains inside (Hao and Hachiya [6]). When aircraft loads are applied to the pavement area in which the delamination between layers is caused by blistering, slippage and significant unevenness may appear on the pavement surface. Several reasons for water remaining in the asphalt mixture can be given including infiltration of rainwater from construction joints, the presence of water when the asphalt mixtures were laid, supply of moisture from concrete slabs, and so on. These reasons, however, could not be ascertained until now.

Black spots were recognized as being composed of the same substances as those of asphalt emulsion and straight asphalt. Asphalt stains were also found on the fractured plane of cores with black spots. Therefore, asphalt might possibly exfoliate from aggregates in some segments.

White spots and stains at construction joints were found on the surfaces of areas where water seeped out from the inside, while they did not exist in asphalt mixtures. Therefore, efflorescence might be coming from the concrete slabs.

The flow of asphalt mixture surrounding airport lights is caused by the insufficient dynamic stability of asphalt mixtures, as mentioned above.

Based on the above study, rehabilitation work, in which the existing asphalt mixture layers are removed and new specially treated asphalt mixture layers are placed, has been planned. Following are the major items that have actually been adopted.

The pavement structure will be such that the surface course is made of dense graded asphalt mixtures 60 mm thick and the binder course is made of drainage asphalt mixtures 40 mm thick. In order to ensure durability in the midst of heavy aircraft loads, 60 mm is required as the thickness of the surface course. Tack coat using polymer modified asphalt is also required on both the binder course and concrete slabs to secure the bonding strength at the interfaces.

Two kinds of water drainage facilities are built into concrete slabs around the rehabilitation area. One is transverse open grooves 6–10 mm in width to drain out water transversely and encourage evaporation, and the other is wider ditches filled with a drainage asphalt mixture to mainly drain out water longitudinally. The plan view is shown in Figure 6.

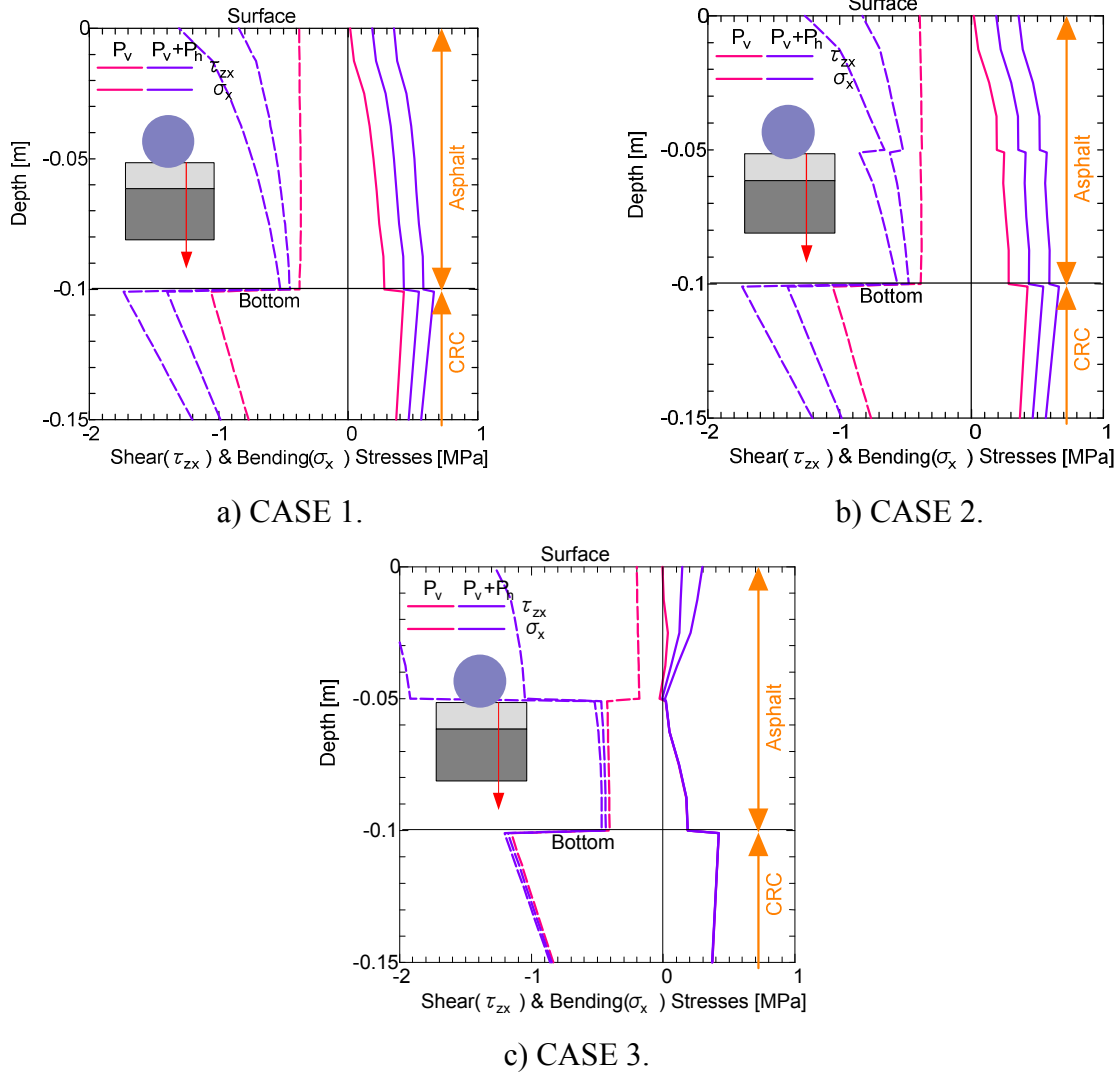
Figure 5. Shear Stress and Bending Stress of Asphalt Mixture Layer throughout the Thickness.

The results of calculation for both the shear stress and bending stress in the asphalt mixture layer are described in Figure 5. This figure shows the distribution of those stresses at a wheel edge throughout the thickness.

In all cases, both the shear stress and bending stress increase as the horizontal load increases. In CASE 1, the continuity of both stresses is observed between surface course and binder course, thus there is little risk of separation between the two layers as long as the bonding strength at this interface is secured. However, there might be higher risk of separation between the asphalt mixture layer and concrete slab as the stress at the interface between them is far larger than that between the asphalt mixture layers. This is the same as when the elastic moduli differ between the surface course and binder course, that is, in CASE 2.

Contrarily, in CASE 3 where the bonding strength between the surface course and binder course is smaller, the shear stress both at the interface and in the surface course increases as the horizontal load increases.
